# Portage Creek Sediment Remediation Project Kalamazoo, Michigan

Pre-Sediment Removal Structure Feature Assessment  
Removal Areas SA1-A, SA1-B and SA1-C

**FLEIS & VANDENBRINK  
ENGINEERING, INC.**

F&V Project Number: 809930  
May, 2013 (Updated June, 2013)

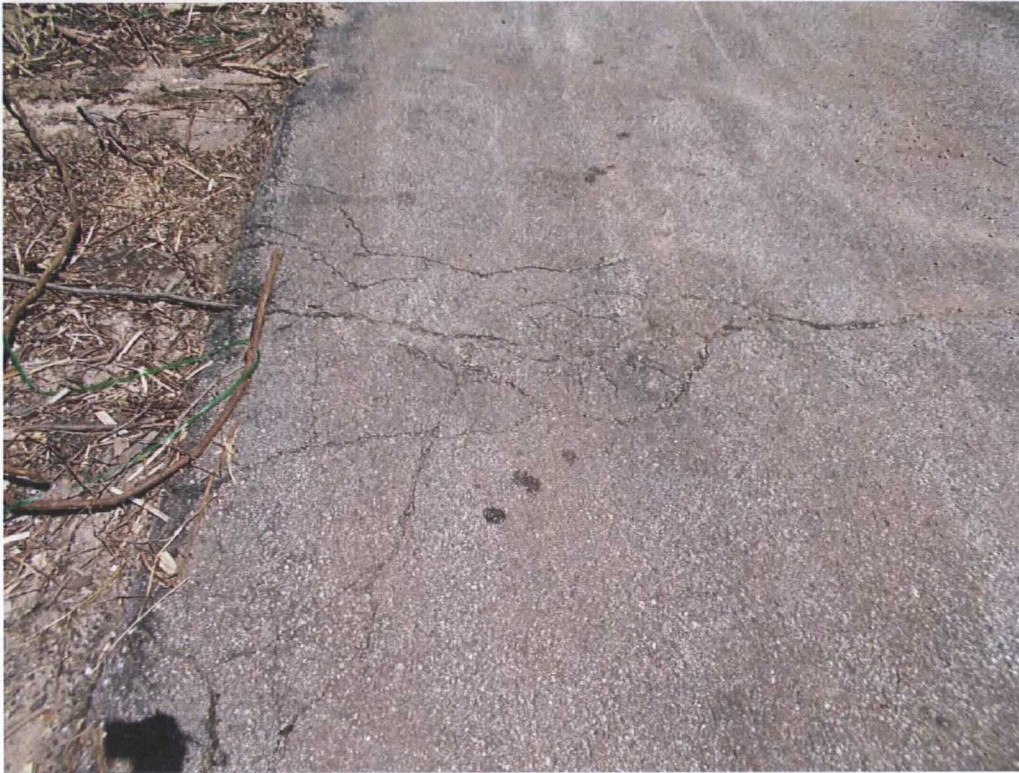
- The asphalt pavement is in fair to poor condition with cracking throughout, some of which has vegetation growth.
- Severe edge cracking and spalling was noted.
- Several areas of settlement and alligator cracking were noted.
- There is a concrete bumper at a commercial dumpster near the north end of the pavement area.

Alligator cracking near edge of pavement

- Repair or replace damaged areas of pavement as required.

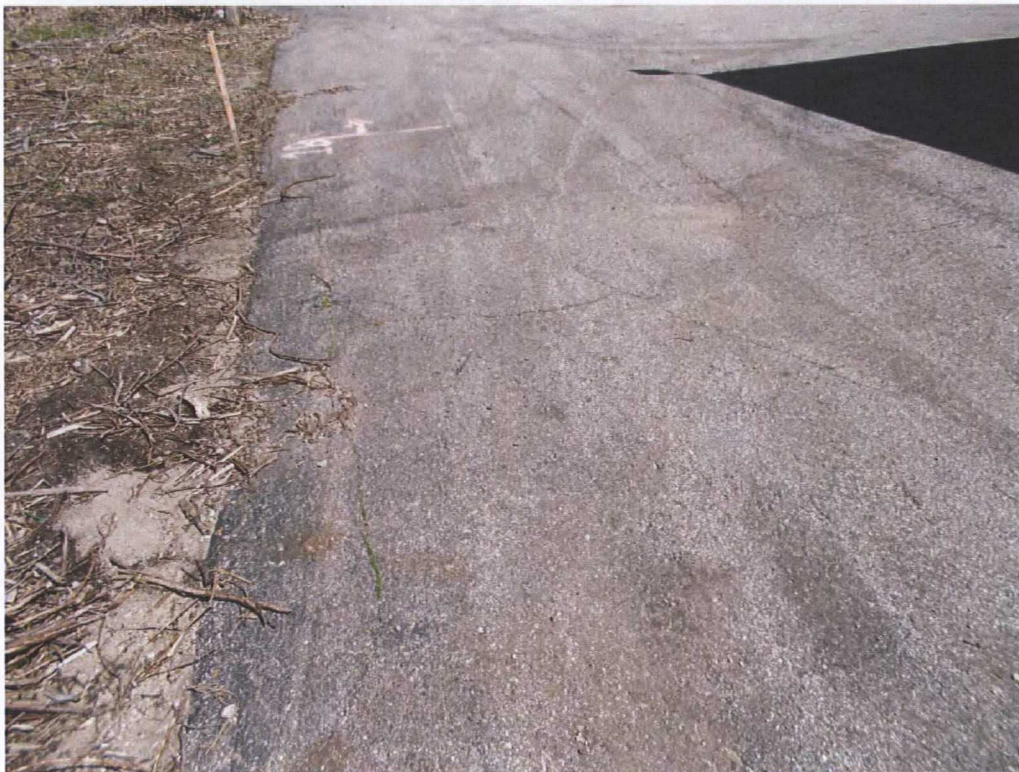
Random cracking in pavement

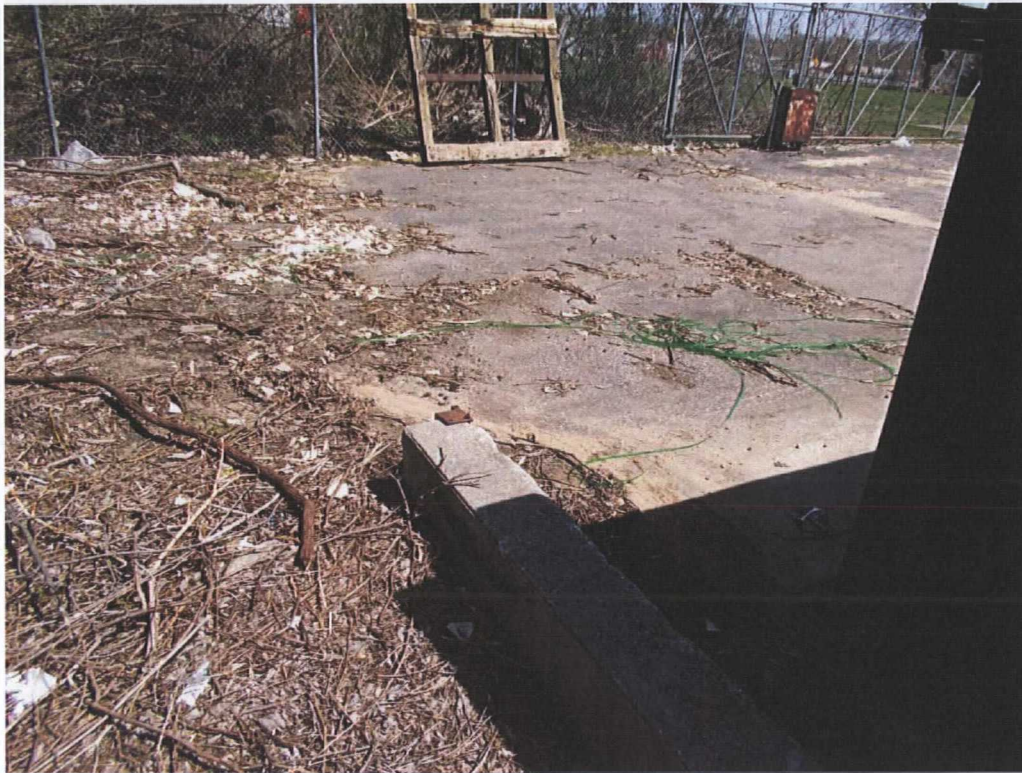
View of pavement north of SA1-B

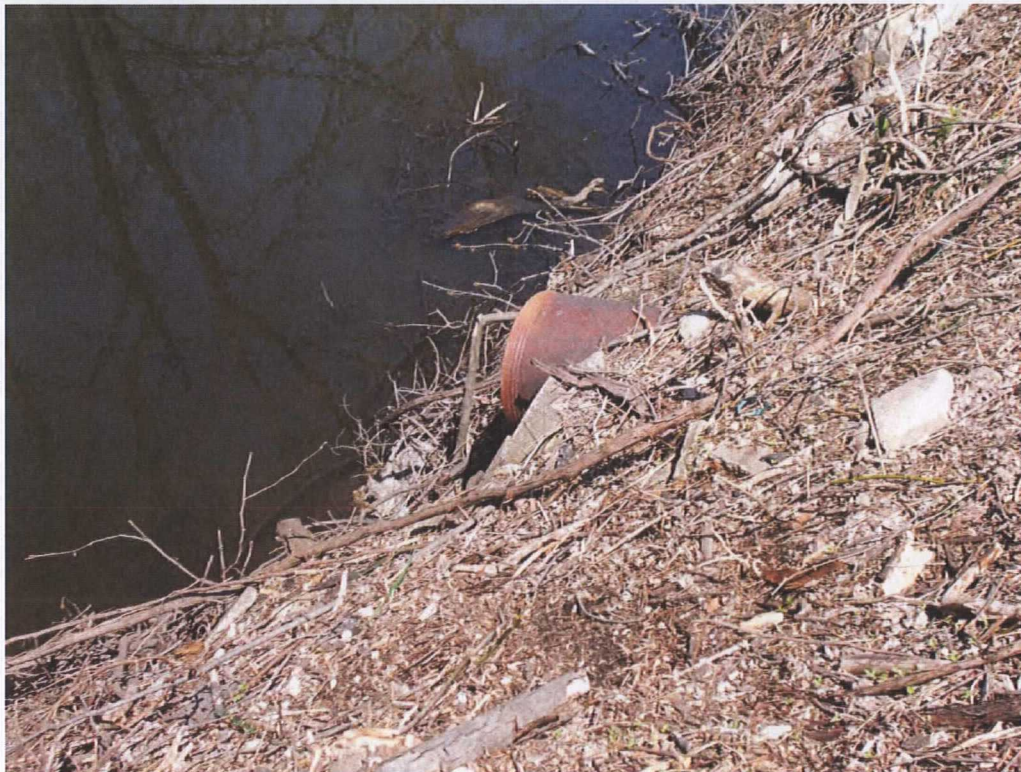
- The outlet is surrounded by the remains of a suspected concrete block headwall.
- Moderate slope erosion was noted around the outlet.
- The pipe is in fair condition. The bottom of pipe is cracked and spalling at the exposed end.

Outlet viewed from the upper bank

- This structure is located south of the southern limits of SA1-B and should be protected from inadvertent damage during sediment removal.

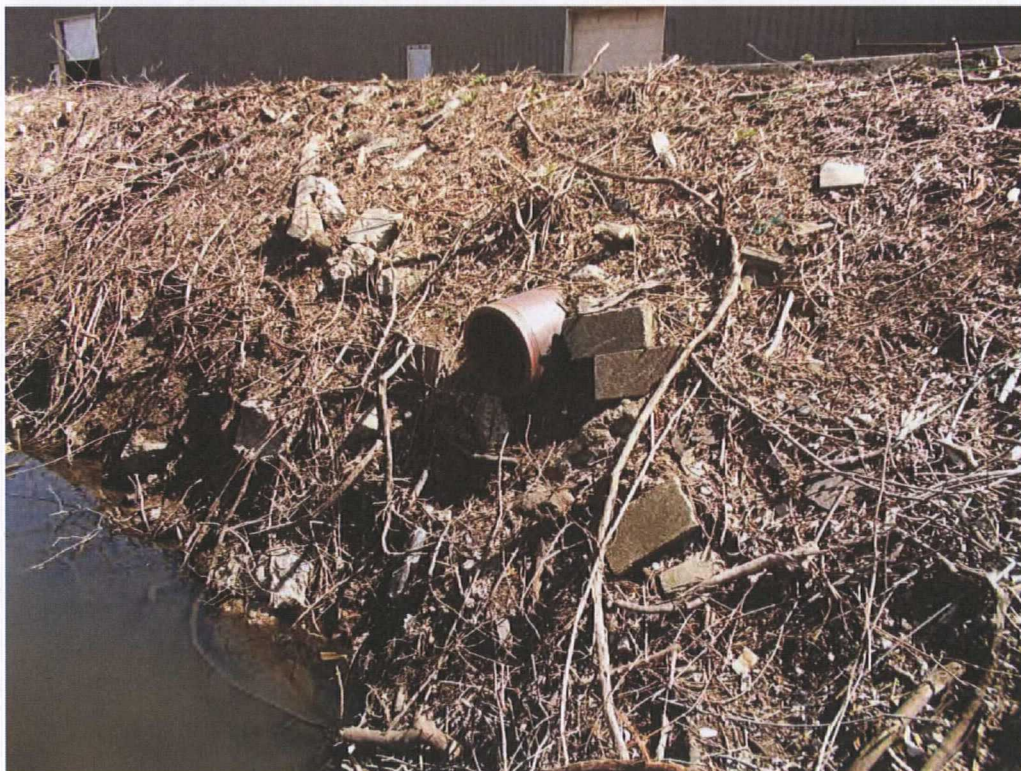
View of the outlet from the channel

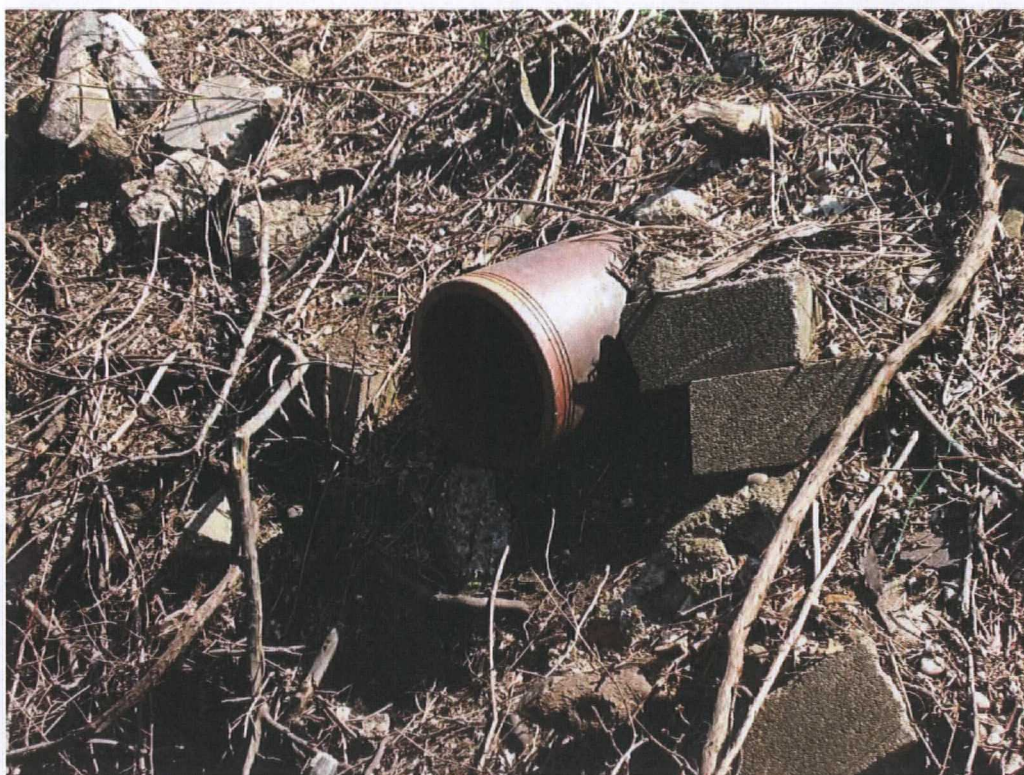
Close-up view of outlet

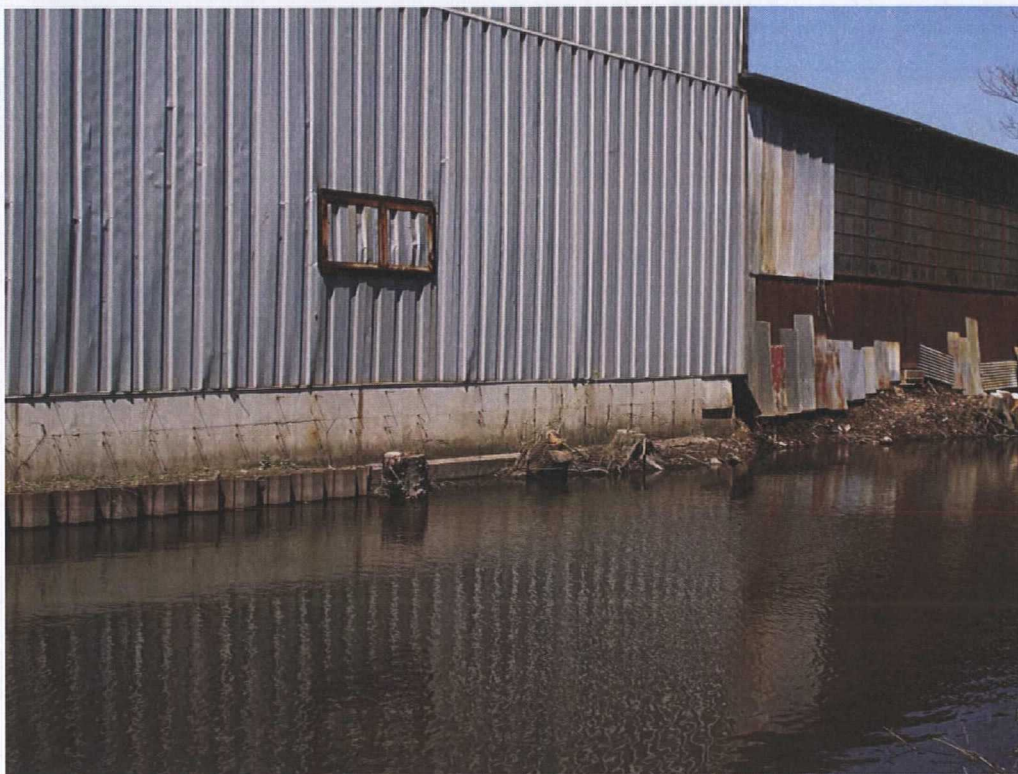
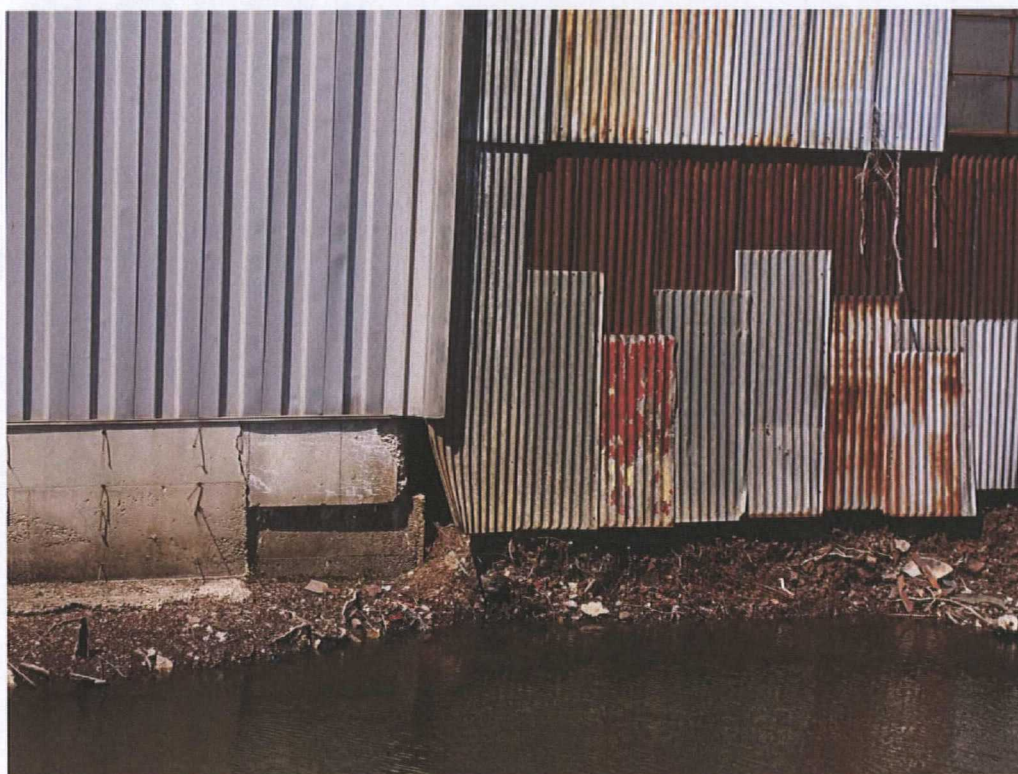
- The siding on the southern portion is buckled and damaged throughout.
- The corrugated siding on the northern section has moderate to severe surface corrosion. It is bent back near the transition between sections and generally in poor condition.

View of building transition from east bank

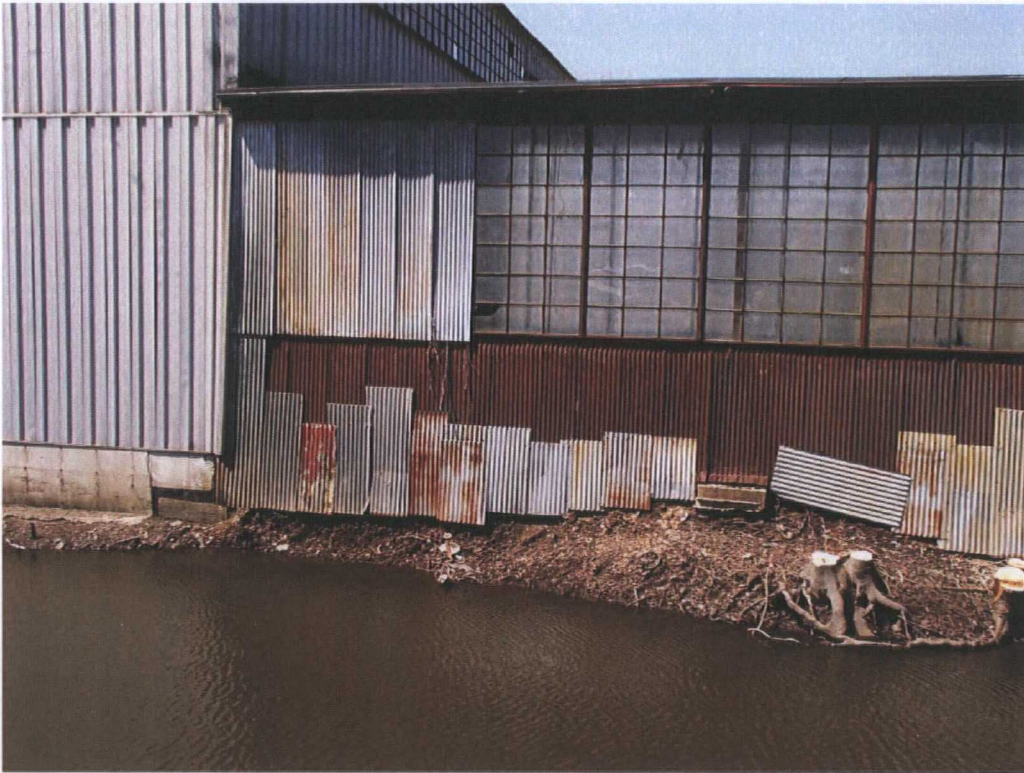
View of south end of northern section from east bank

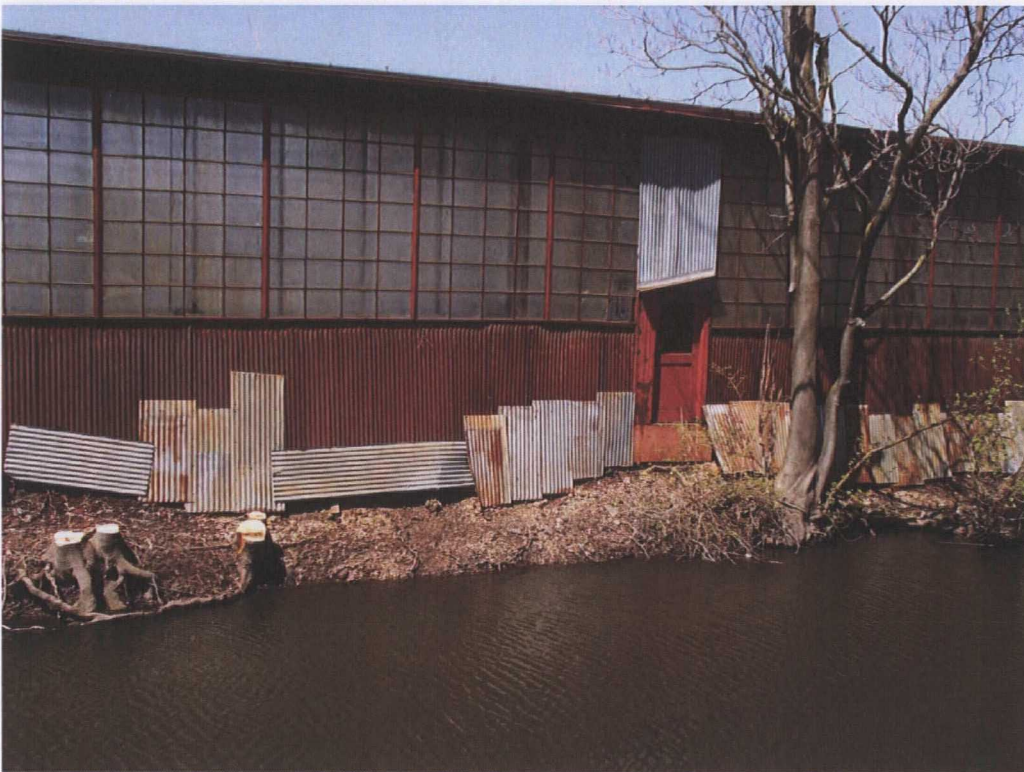
View of northern section from east bank

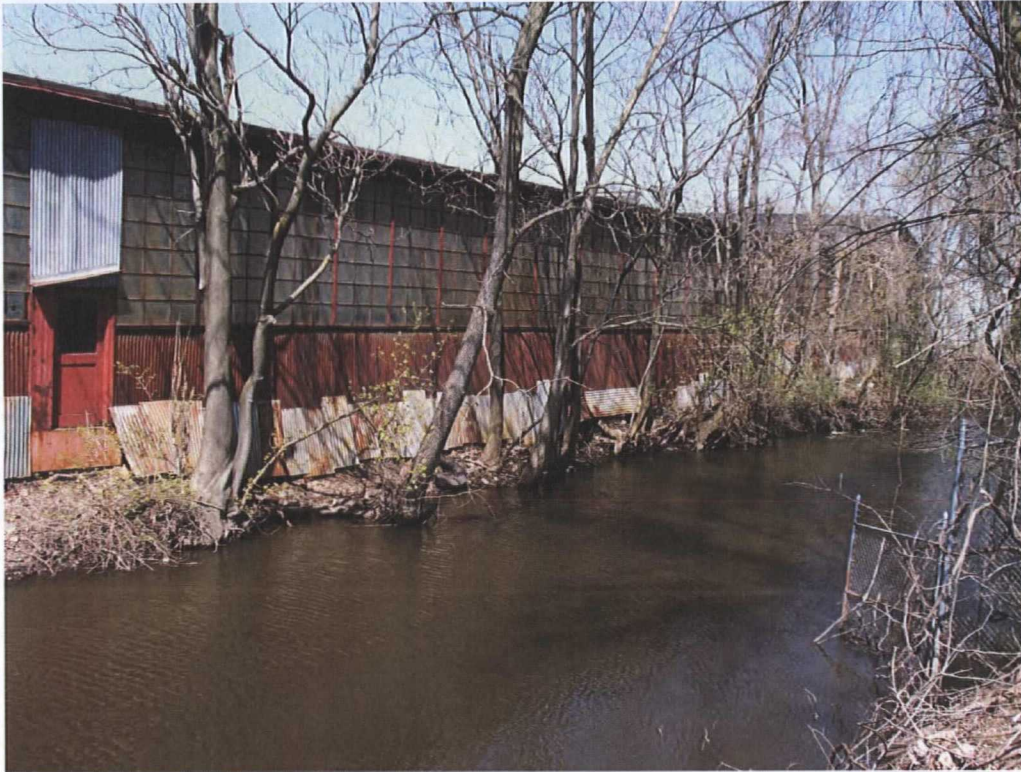
- The bank north of the sheet pile is mostly intact due to a series of large trees and stumps. The footing of the northern end of the concrete foundation wall is exposed approximately 8-12 inches.

View of trees supporting the west bank

- Due to the limited sediment removal depth (approximately 1 foot), it should be possible to remove sediment against the sheet pile wall without disturbing it.
- It is recommended that the bank north of the sheet pile wall be left intact to avoid impacting the unknown foundation for the northern section of the building. If the bank cannot be left in place, a longitudinal cofferdam is recommended along the building with a minimum clearance of approximately 4 feet.
- Avoid excavation within 3-4 feet of the exposed concrete footing to prevent undermining or other disturbance.

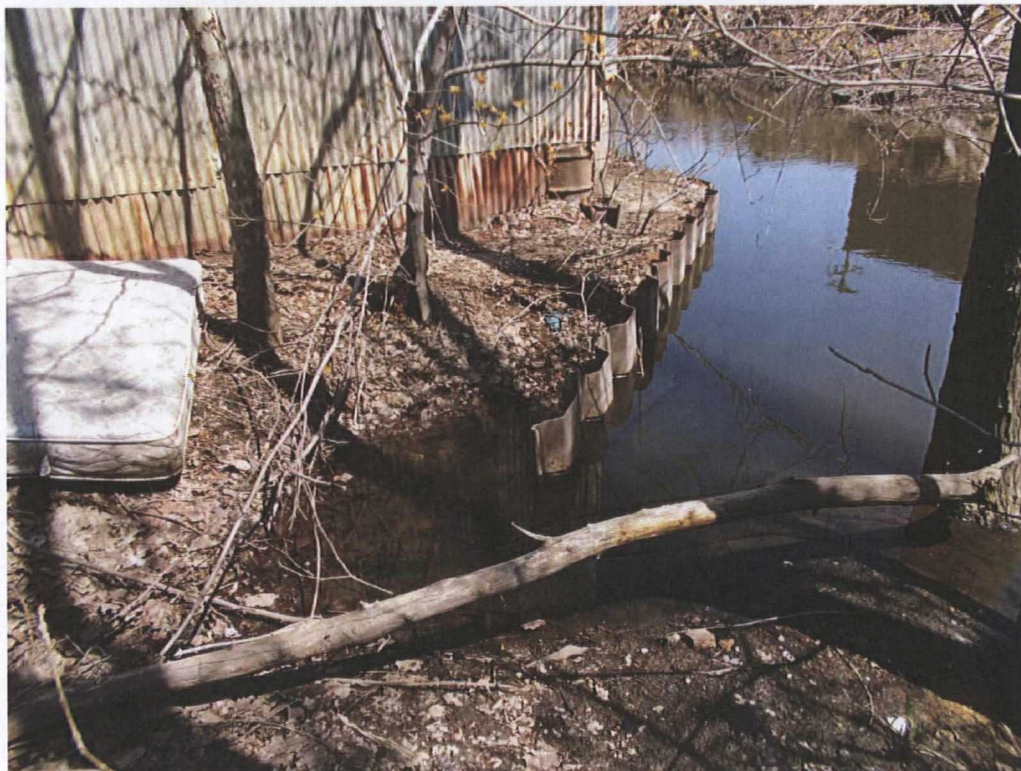
South end of sheet pile at southeast corner of building

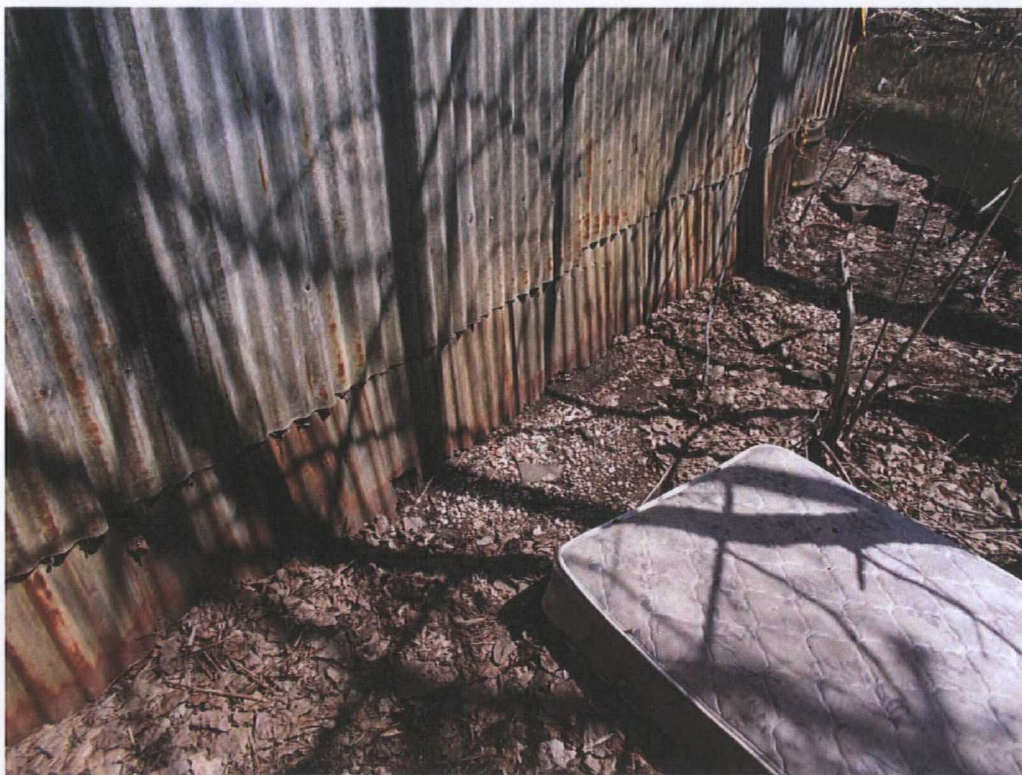
Corrugated siding on south face of building

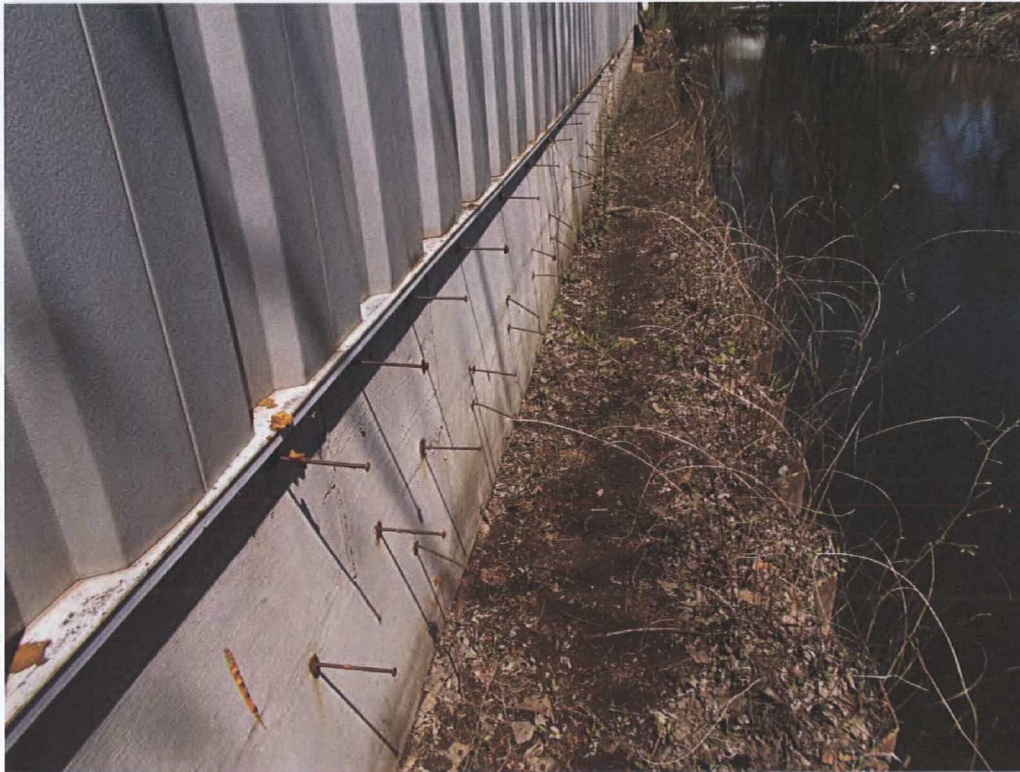
View of concrete foundation wall looking north

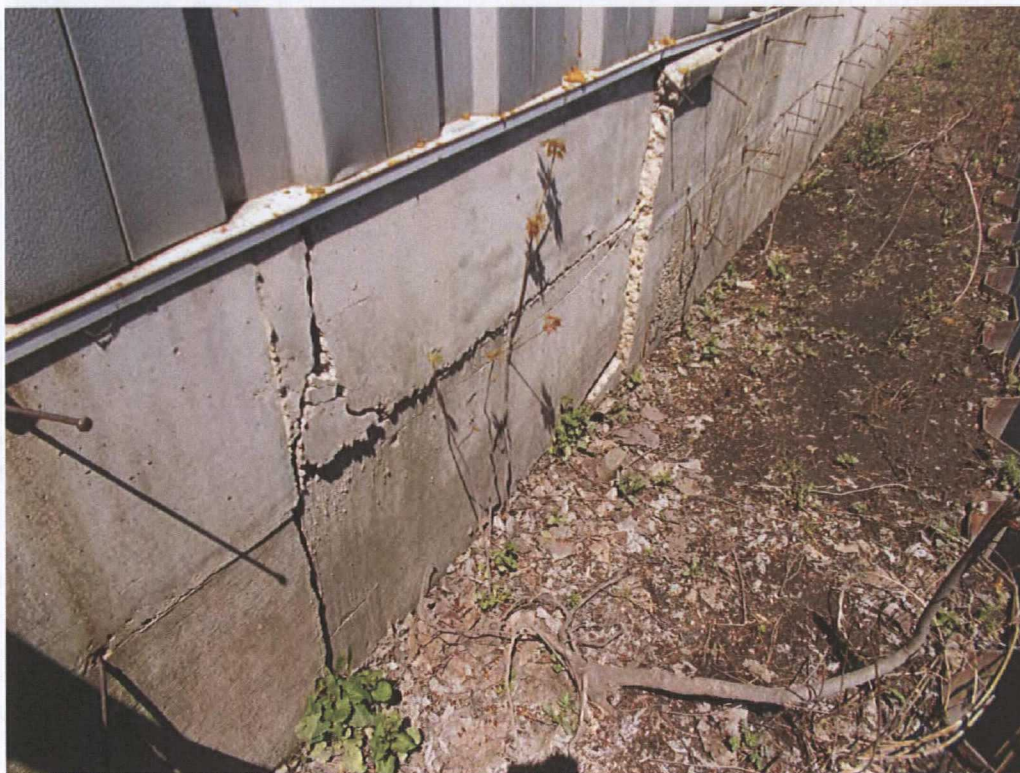
- The channel is 3.5-4.0 feet below the top of sheet pile.
- The concrete foundation wall has moderate honeycombing at pour joints. There is an area of critical vertical cracking with a 2" offset in the wall near the change in roof lines. There is a moderate vertical crack near the north end of the sheet pile.

Area of critical cracking in concrete foundation wall

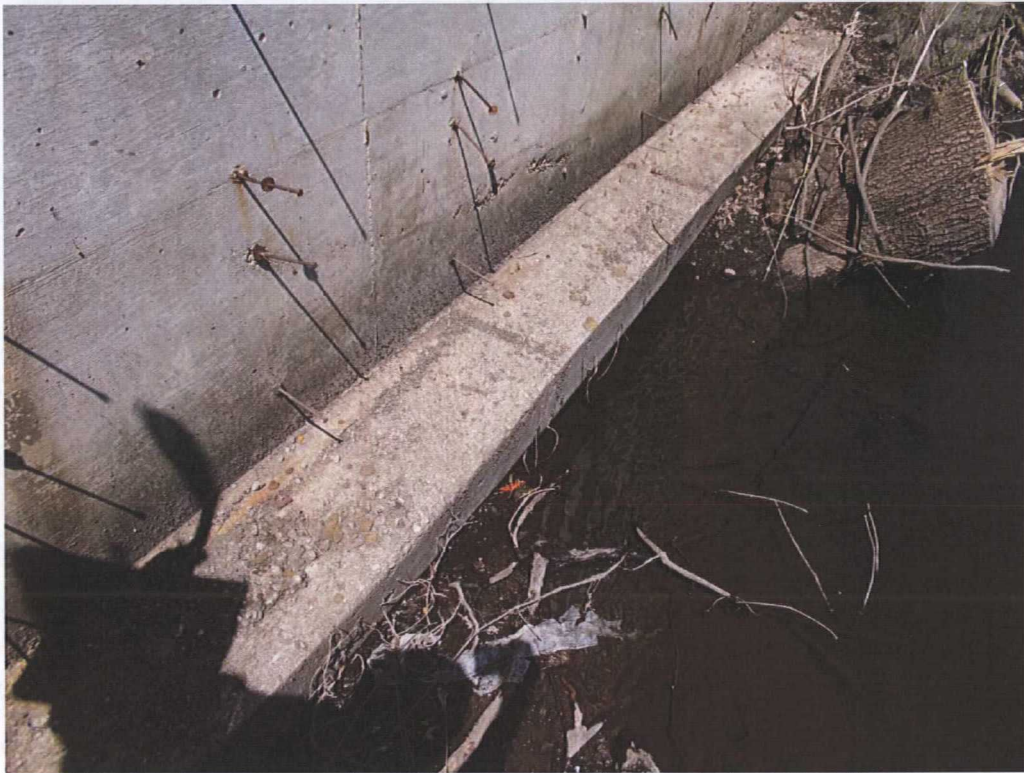
Exposed footing at north end of southern section of building

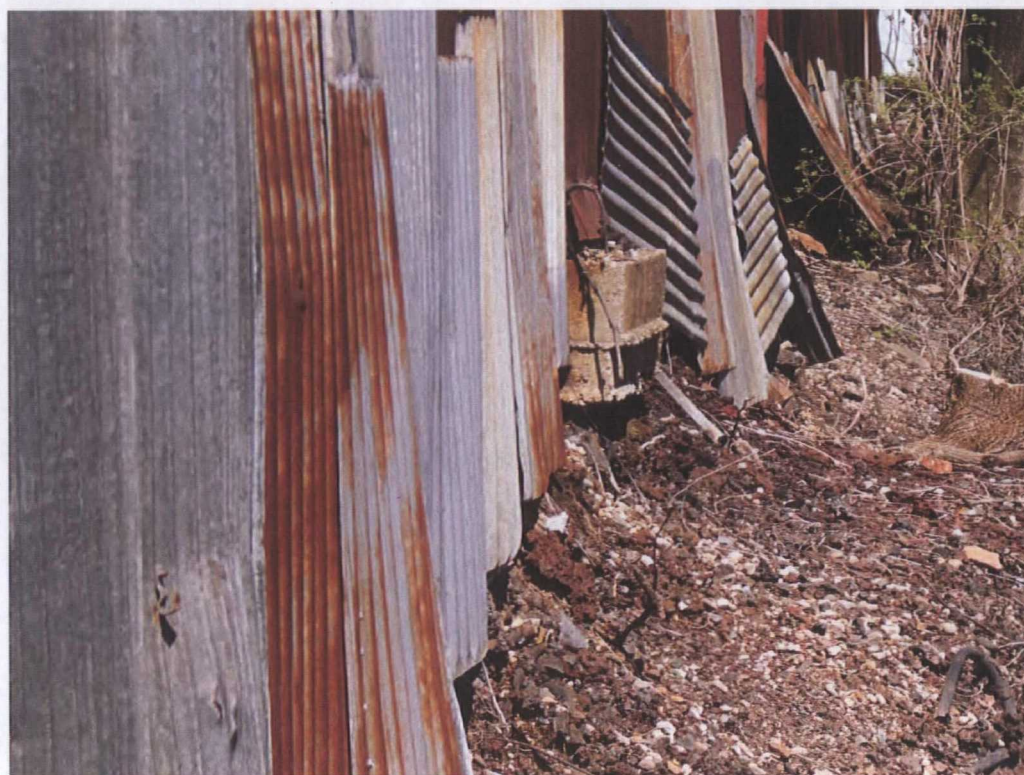
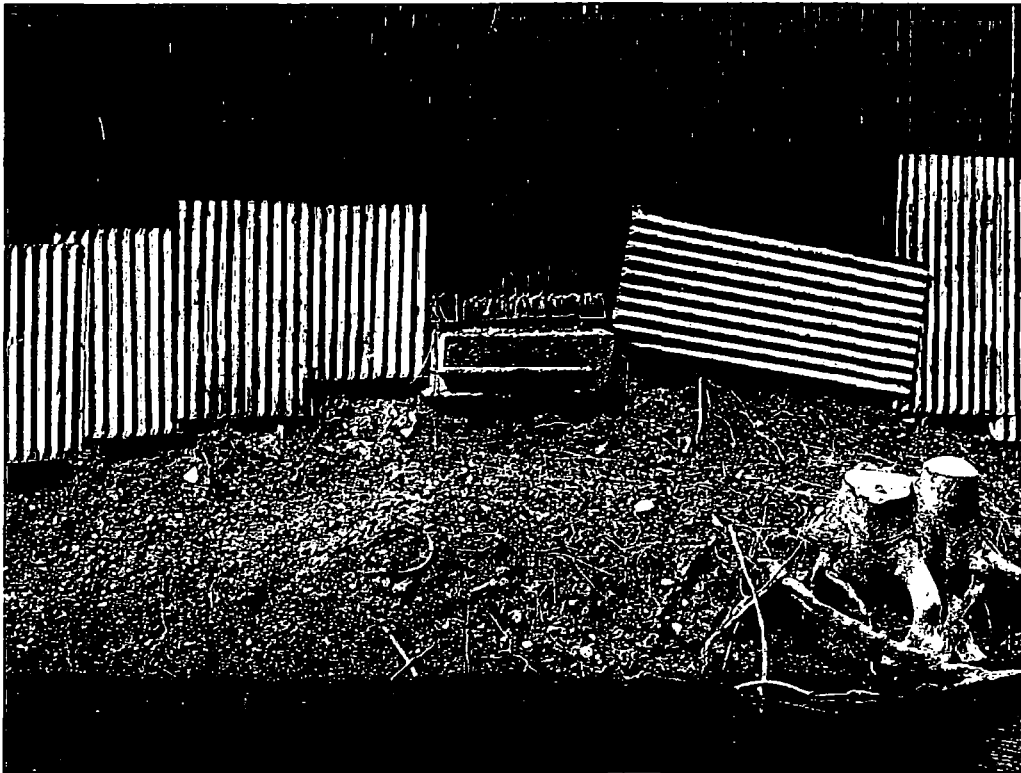
- There is an apparent column foundation in the northern section which is located well above the waterline and appears to be severely undermined.

View of suspected column footing in northern section looking north

View of suspected column footing in northern section from east bank

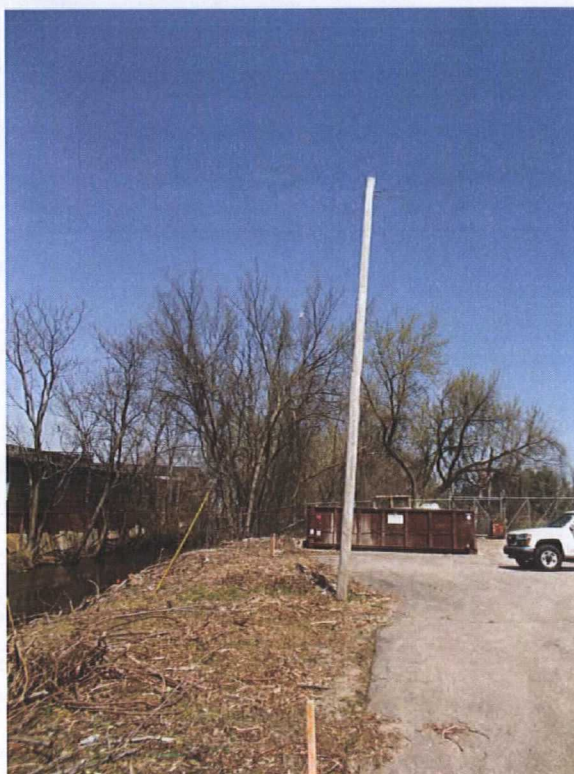
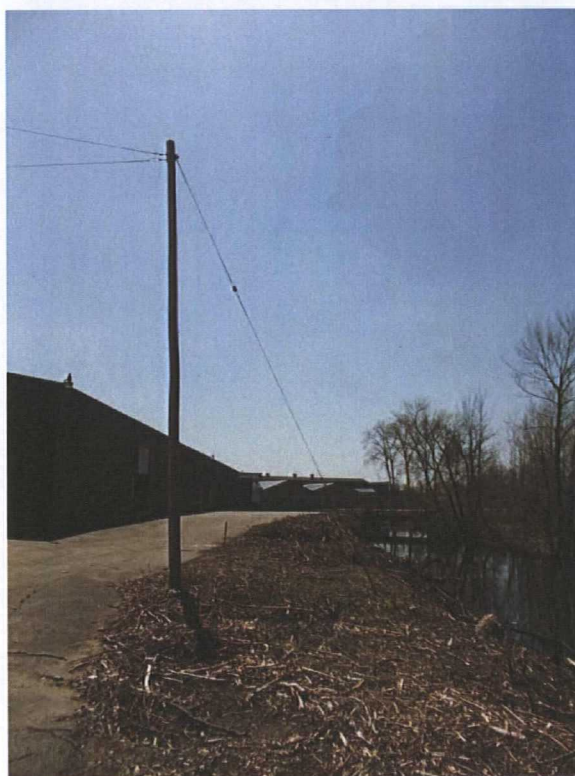
- The guy pole has a slight easterly lean.
- The pole and guy appear to be in fair condition.

View of the guy pole and wire looking north

View of the guy pole and wire looking south

- The guy pole and wire appear to be beyond the influence of the sediment removal in the area due to its shallow nature. Construction fencing or similar means should be used to identify the pole and guy to operators and drivers during the work.

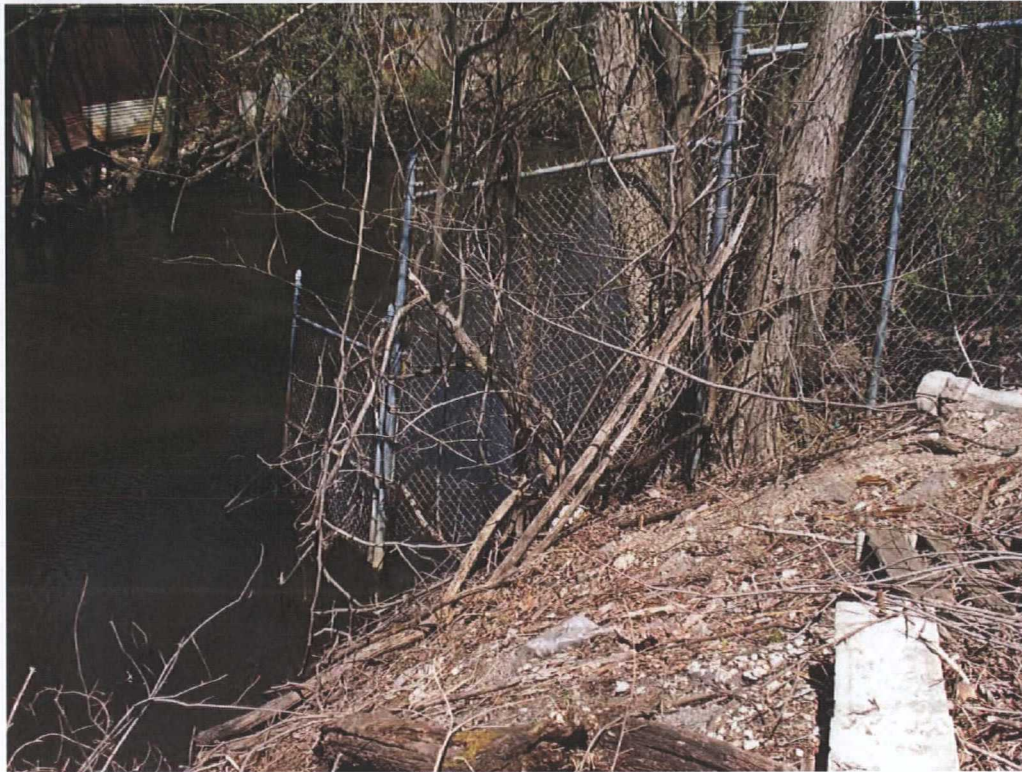
- The fence is in fair to good condition.
- The west end of the fence in the channel appears to be deflected to the north, presumably from impact by channel debris.

View of the fence looking north

- The fence is located north of SA1-B and is not likely to conflict with sediment removal operations. However, if the fence does conflict, it should be removed and replaced in kind.

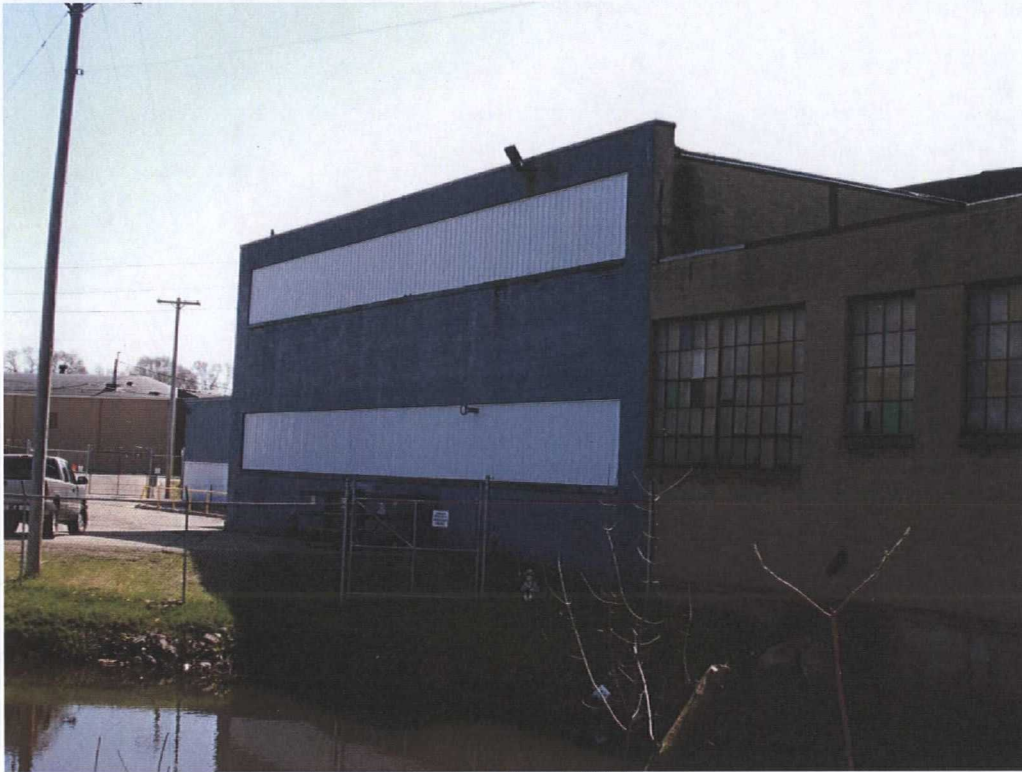
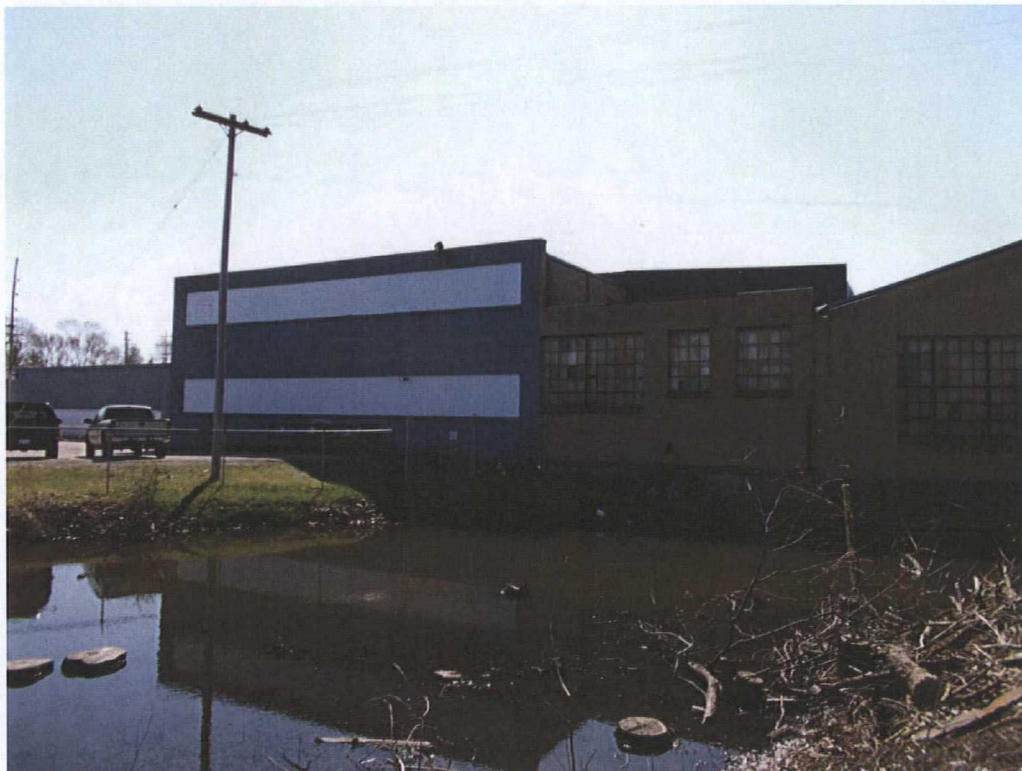
View of structure from northwest

Overall view of structure from the north

- Maintain 4-6 feet minimum clearance between the southern sheet pile cofferdam and the building. Based on the configuration of the building in relation to the field staking, this should be achievable.
- Utilize Miss Dig flagging to confirm that the gas and water main crossings are beyond the cofferdam limits.

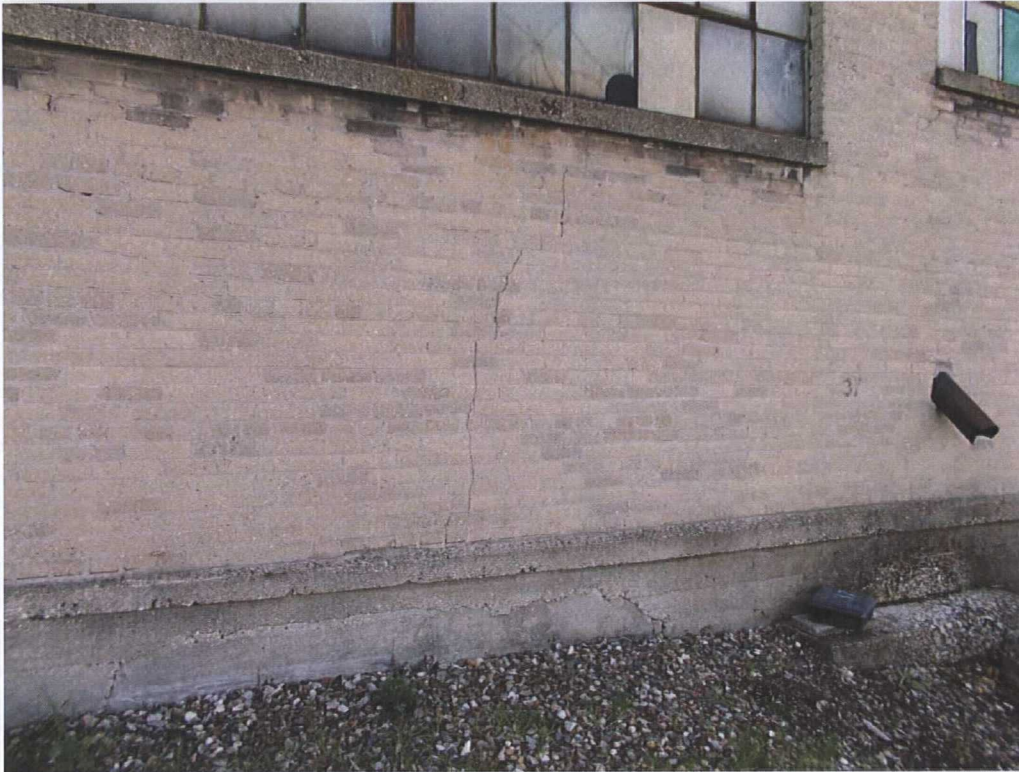
- Minor cracking, severe honeycombing and exposed form ties were noted in the concrete foundation wall.
- The footing is exposed upstream of SA1-C. Minor undermining was noted at the building transition.
- Moderate vertical and step cracking were noted in the brick. Cracking was noted in the primary wall and originating at window penetrations.
- A minor horizontal crack was noted between the concrete foundation and brick near the building transition.
- The eastern section of the building has sealed diagonal/step cracking near the fence line.
- Consumers Energy mapping shows a 2" gas crossing Portage Creek, however it appears to be west of SA1-C-S01 and outside the cofferdam limits.
- City of Kalamazoo mapping shows a water main crossing Portage Creek, however it appears to be west of SA1-C-S01 and outside the cofferdam limits.

Step cracking in brick wall

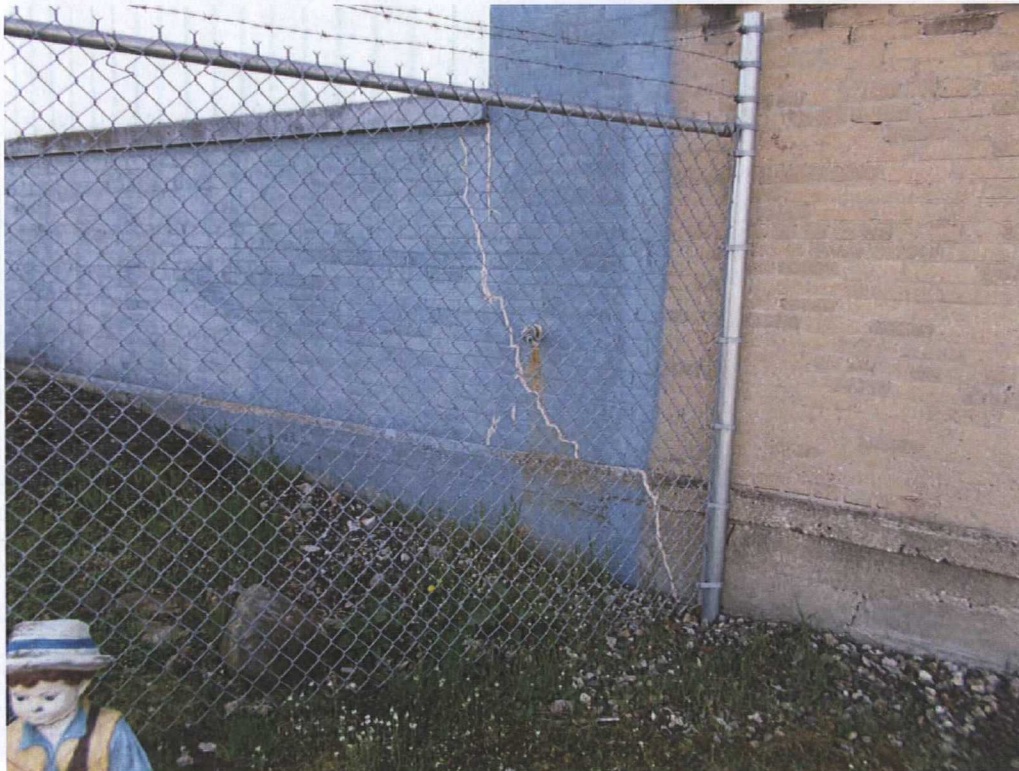
Sealed step/diagonal cracking in brick wall

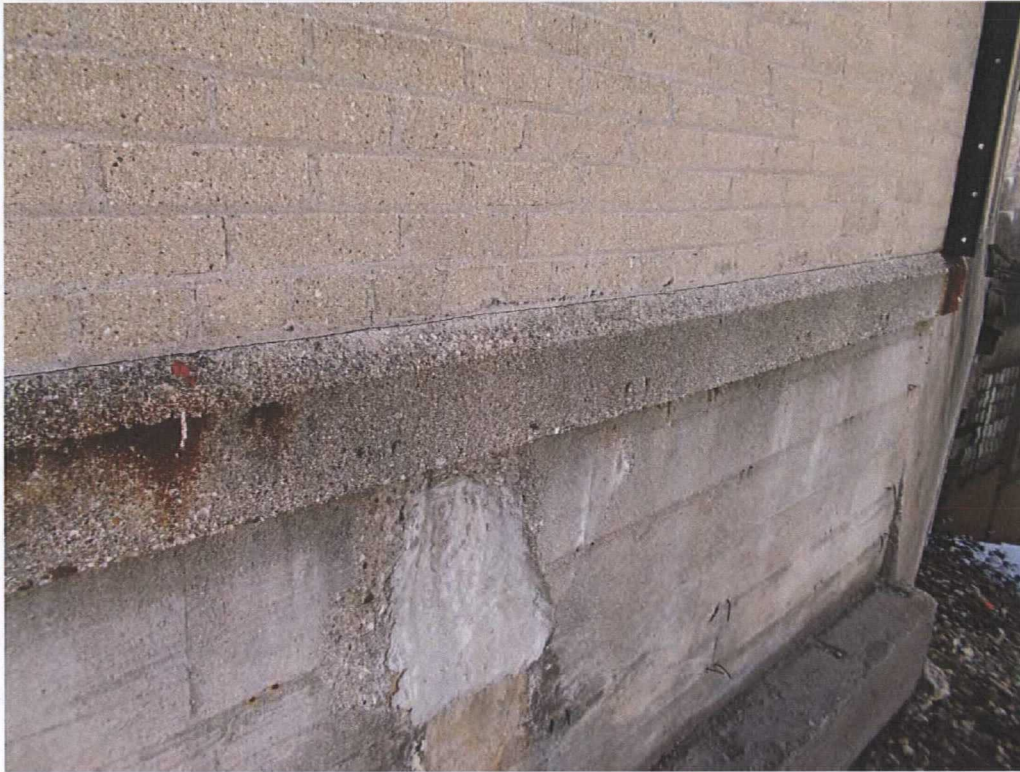
Cracking between foundation and brick

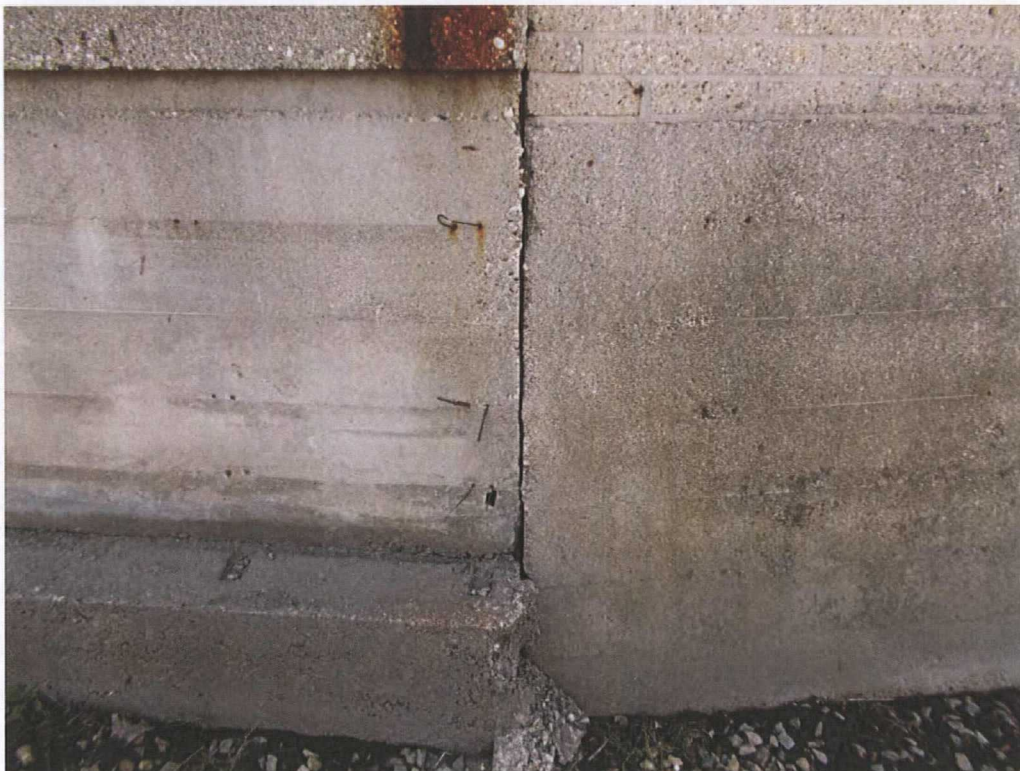
Joint separation at building transition

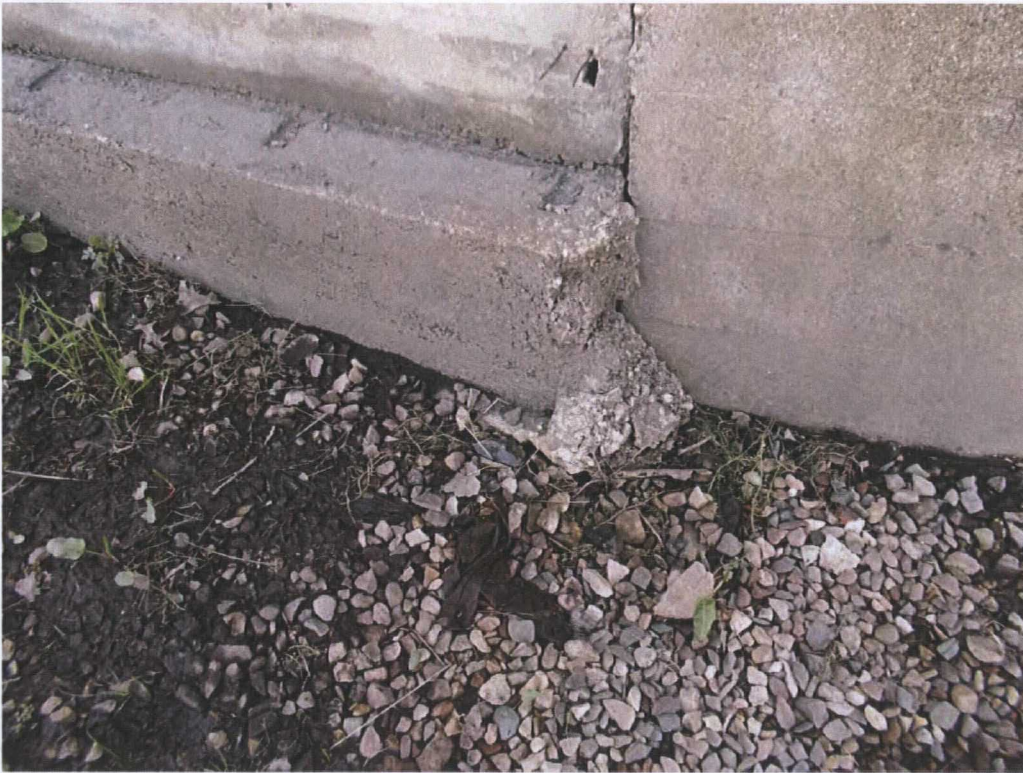
Footing undermining at building transition
